O GRADSKIM BEDEMIMA
ANTIČKE DOKLEJE

ON CITY WALLS OF
ANCIENT DOCLEA

Rad se temelji na rezultatima dobijenim sa snimanja gradskih bedema i vidljivih arhitektonskih objekata Dokleje, koja su obavljena 2012. god¹. Njime se iznose razmišljanja potaknuta terenskim zapažanjima nastala tom prilikom.

The work is based on the results obtained from the surveying of the city walls and visible architectural structures which were carried out in 2012¹. It presents the thoughts that were triggered by field observations made on that occasion.

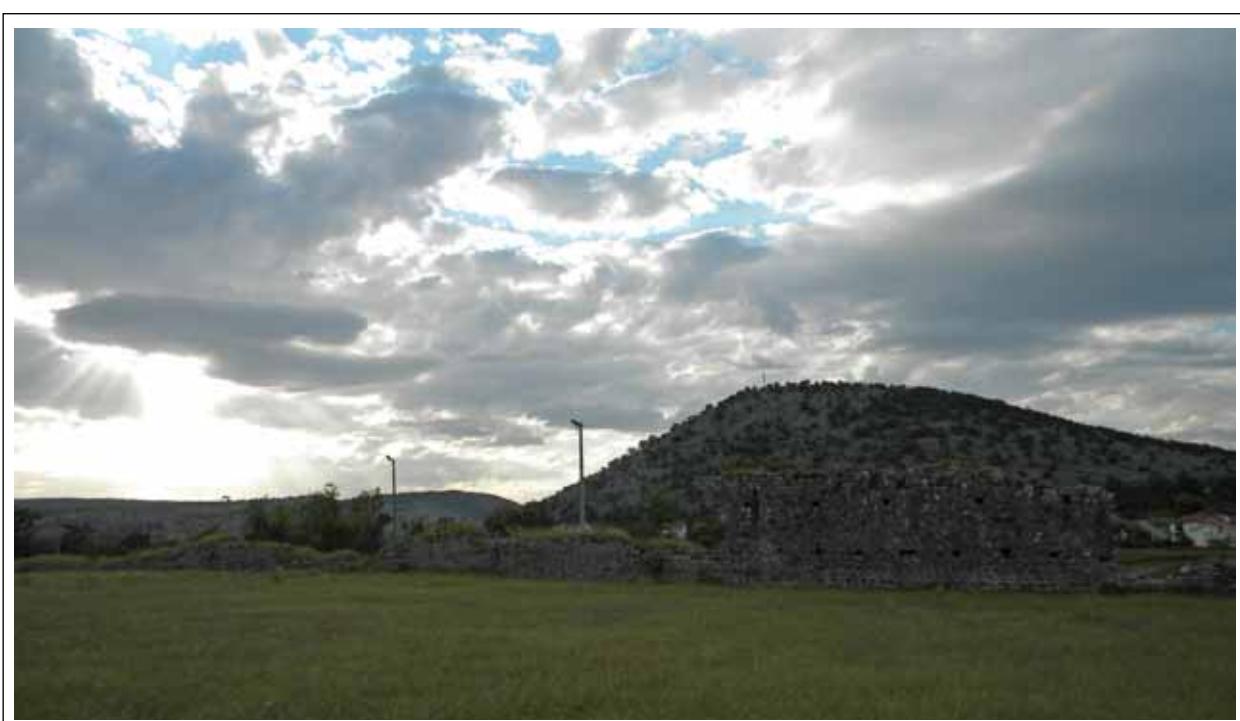
Sl. 1 - Unutrašnji izgled sjevernog bedema
Fig. 1 - The inside of northern city wall

Starting from t the wall is broken three times and in some way it makes a curve (Fig. 1) where the most complete segment of bulwark is now preserved. At the ends of this piece of the wall, we can see a cross section of the wall, which allows us to determine the method of construction and composition of the interior wall of the rampart (Fig. 5). As the wall faces were built in rows, so was the riprap gradually filled with stone and mortar with a lot of lime in it. Generally speaking, the upper part of riprap has smaller pebbles, while the lower part is mainly made of large pebbles and bigger parts of crushed stone. On the inner side of the wall, two lines of holes made for wooden beams can be seen. The lower line has seven holes with the distance of 1.15m to 1.30m between each other and is located at 1.10m above the ground level. The openings are rectangular in shape, with the most common dimensions of $0.20\text{m} \times 0.25\text{m}$. The five openings in the upper line have the same shape and dimensions, and they are located at 2.8m above the ground. The openings are located at greater distances, ranging

Od mjeseta t zid se tri put lomi i na neki način pravi krivinu (sl. 1) gdje je sačuvana danas najkompletnija particija bedema te čemo se na njoj malo više zadržati. Na krajevima ovog komada bedema vide se presjeci kroz bedem koji nam omogućuju da odredimo način izgradnje i sastav unutrašnjosti bedemskog zida (sl. 5). Kako su i lica zidana u redovima tako je i trpanac postepeno zapunjavan kamenom i malterom sa puno kreča u sebi. Uopšteno govoreći gornji dio trpanca u profilu bedema ima više sitnijeg oblutaka dok donji dio je mahom rađen od većih oblutaka i krupnog lomljenog kamenja. Sa unutrašnje strane zida uočljiva su dva niza otvora za drvene grede. Donji niz ima sedam otvora međusobne udaljenosti od 1,15m do 1,30m i nalazi se na 1,10m od nivoa tla. Otvori su pravougaonog oblika najčešćih dimenzija 0,20m x 0,25m. Istog oblika i dimenzija su otvori u gornjem nizu koji se nalazi na 2,8m od tla i čini ga pet šupljina. Otvori se nalaze na većoj razdaljini 2,30-2,80m mada to nije pravilo kod ostalog dijela bedema gdje je evidentiran manji razmak, te se ne može izvući generalizacija u postavljanju istih. Međutim zapažena je važna razlika između ova dva niza – otvori u gornjem nizu su se protezali cijelom širinom bedema tako da se otvori nalaze i na spoljašnjem licu zida dok su se otvori donjeg niza završavali u zidnoj masi bedema. To povlači i pitanje funkcije ovih greda. Stikoti je predložio da su služili za noseće grede na kojima je postavljan

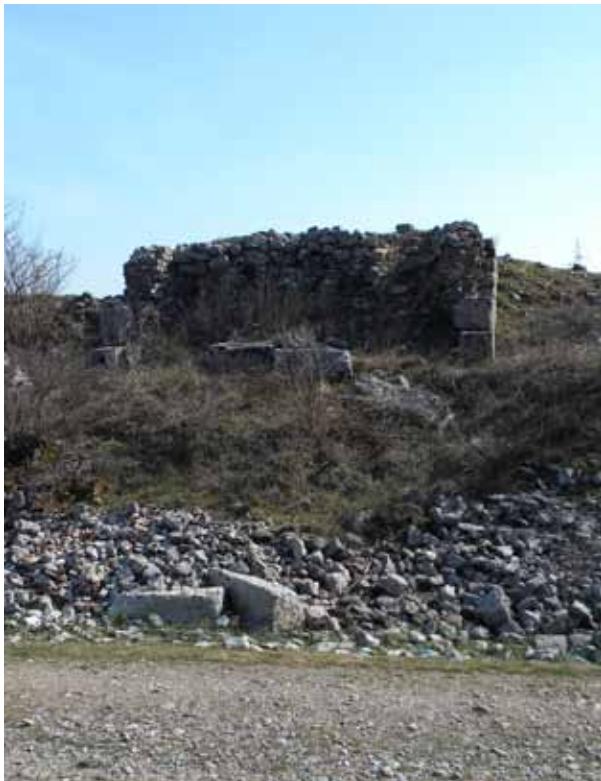
*Sl. 2 - Kula c, spoljašnji izgled sa sjevera
Fig. 2 - Tower c, the outside view from the north*

Nije isključeno da na mjestu *s* gdje se zid sa obje strane sužava, bio jedan od manjih antičkih prolaza na sjevernom bedemu. Naime na tom dijelu bedema ima nekoliko manjih prolaza, ali vjerovatno da je većina probijena zbog stambenih kuća koje se vide i na Stikotijevom planu od kojih su tri i danas naseljene. Na pomenutom mjestu postoji prolaz koji služi kao pristup kamenoj kući i objektu za smještaj ekipe. Iza kuće bedem je prezidan međom. Nakon opisanog prolaza bedem ide istom širinom do mesta *u*. U tom prostiranju registrovana je jedna kula *c* (sl. 2) do koje se, uslijed velike aglomeracije šuta, ne vidi spoljnje lice bedema.

Ispred kule pravougaone osnove, dimenzija 6,5 x 3m, nalazi se rov koji je većim dijelom zatrpan. Cijela sjeverna strana kule je obrušena, i u rovu se nalazi pet velikih kvadratnih blokova. Kvadratni blokovi su činili temeljnu zonu kule i najmasivniji koji je sačuvan *in situ* ima širinu 0,55, dužinu 0,80

In front of the rectangular tower, 6.5 x 3m, there is a trench that was mostly buried. The entire north side of the tower has fallen down and there are five large square blocks in the trench. Square blocks were part of the base zone of the tower and the most massive that has been preserved *in situ* is 0.55m wide, 0.80m long and 0.60m tall. Pieces in the trench have larger dimensions, especially the length, which ranges up to 2m. Sticotti also noted

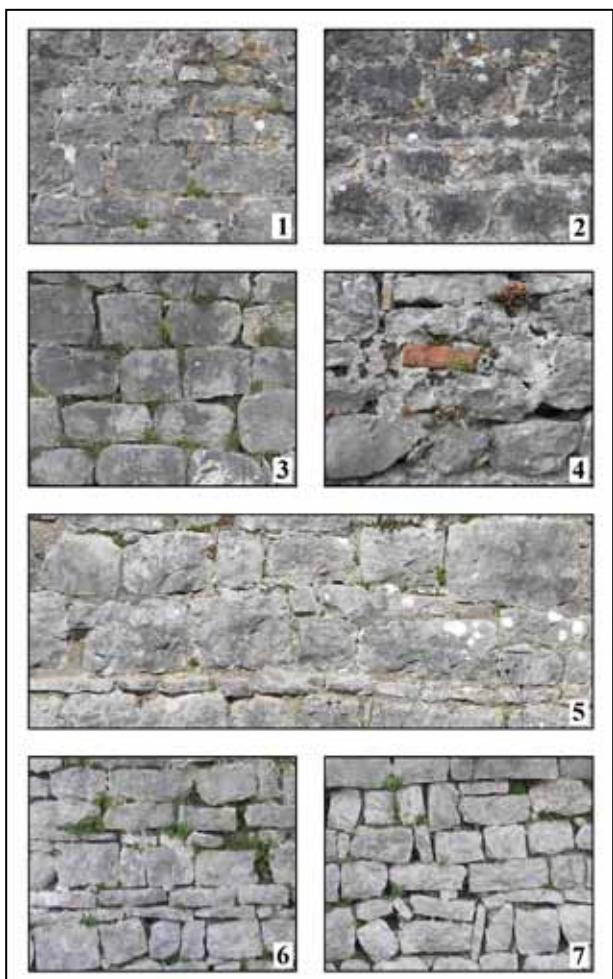
Sl. 3, 1-7 - Izdvojene osnovne tehnike zidanja bedema

Fig. 3, 1-7 - Featured basic techniques of building the city walls

The face of the tower has not been preserved so we cannot see if it was built differently. As stated in the text, the best preserved and most massive side of the rampart (SW, S and SI) was built identically. It was built so that its inner and outer faces have rectangular cut rubble in regular horizontal rows and the core of the wall is filled with crushed stones, pebbles and lime mortar (riprap). This type of building has been recorded in other structures of Doclea. Most building materials (i.e. stones used to build walls) are assumed to originate from Spuž and Miljat hills (Sticotti 1999: 47-49). In general, small and medium-sized roughly hewn rectangular stone blocks measuring approximately 0.30 x 0.20m (Fig. 3,1-3) were used. But, there are also exceptions. Often, horizontal rows of narrow stones can be found in walls (Fig. 3,5 and 3,6). Sporadically, and more to fill the gaps between the stone blocks, bricks appear, placed both vertically and horizontally (Fig. 3,4). While in some places, proper horizontal line was not followed, but the gaps were filled with stones of various sizes and shapes (Fig. 3,7). Most walls are nicely grouted; gaps or joint fillers are complete (Fig. 3,1; 3,4 to 5) although in some areas they have fallen off (Fig. 3,3; 3,6 to 7). In some places, traces of the tools which were used for grouting can be found (Fig. 3,2).

Opisan način gradnje manjim i srednjim ugrubo tesanim kvaderima dimenzija oko $0,30 \times 0,20\text{m}$ (sl. 3,1-3) je generalan i ima izuzetaka. Nerijetko se u zidnim platnima javljaju horizontalni redovi uskih podužnih kamenja (sl. 3,5 i 3,6). Sporadično, i više da bi se uklopile praznine među kamenim kvadrima, pojavljuju se i opeke, koje se postavljaju i vertikalno i horizontalno (sl. 3,4). Dok se na nekim mjestima nije pratio pravilan horizontalan red već su se praznine popunjavale kamenjem raznih dimenzija i oblika (sl. 3,7). Zidovi su takođe većinom lijepo fugovani, praznine odnosno fuge su se u potpunosti popunile (sl. 3,1; 3,4-5) mada su na nekim djelovima i otpale (sl. 3,3; 3,6-7). Negdje su vidljivi i tragovi alatke s kojom se fasada zida fugovala (sl. 3,2).

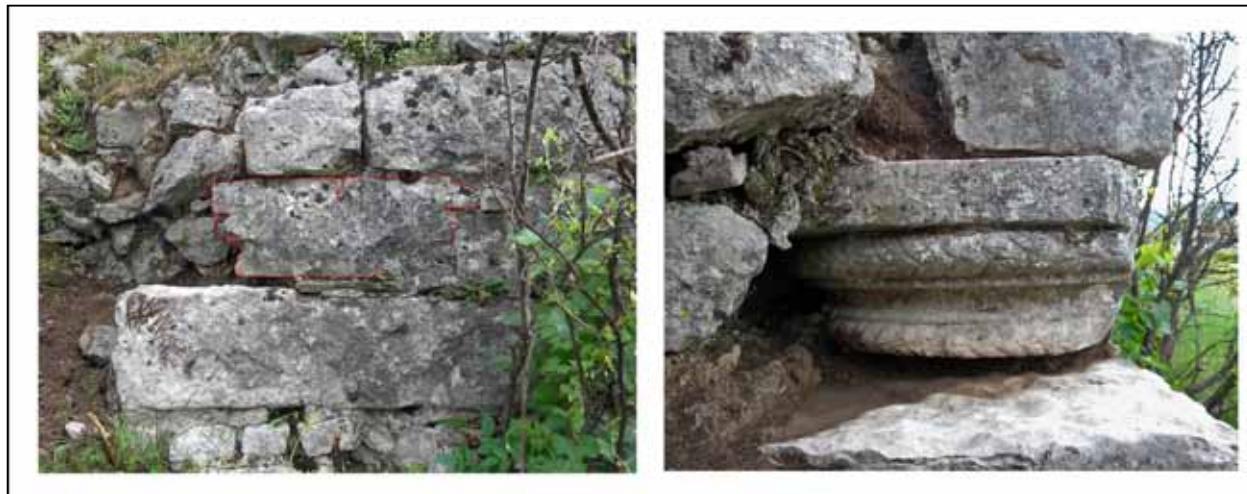
Sl. 4 - Baza stuba uzidana u spoljašnje lice sjevernog bedema

Fig. 4 - The base column built into the outer face of the northern city wall

At point t, where the outer wall surface begins to break, and 0.60 m above the ground, an interesting *spolia* was found. An Attic - Ionic base was built into the wall structure. It is placed upside down (Fig. 4) and hewn so that it cannot be noticed that it was once an architectural decoration. It is clear that it was the utility of this *spolia* that was

Na mjestu t gdje zid počinje da se lomi u spoljnjem zidnom platnu, na $0,60\text{m}$ od tla uočena je interesantna spolija. U zidnoj strukturi bedema uzidana je atička baza stuba (Attic – Ionic base) postavljena naopako (sl. 4) i isklesena tako da se ne primjećuje da je nekada bila arhitektonski ukras. Jasno je da se prilikom ugradnje ove spolije gledalo na utilitarnost spomenutog kamena. Širina bazne ploče odnosno plite je $0,60\text{m}$, prečnici torusa se nisu mogli tačno izmjeriti, dok je sačuvana visina baze $0,23\text{m}$. Ukupna visina baze bila je $0,25\text{m}$ od kojih je $0,07\text{m}$ iznosila plinta, $0,06\text{m}$ donji torus, $0,01\text{m}$ profilna traka, $0,04\text{m}$ je išlo na skocij-kaneluru, zatim $0,01\text{m}$ na profilnu traku i na kraju $0,06\text{m}$ na gornji torus (sačuvano samo $0,04\text{m}$). Torusi baze su karakteristično ukrašeni tako da

important. The base plate (i.e. plith) is 0.60 m wide, the diameters of the torus could not accurately be measured, and the preserved height of the base is 0.23 m . The total height of the base was 0.25 , with 0.07m for the plinth, 0.06m for the lower torus, 0.01m for lower fillet, 0.04 m for scotia, 0.01 m for upper fillet, and finally 0.06m (preserved only 0.04m) for the upper torus. The tori of the base are decorated so that they make up two wreaths twisted in different directions.

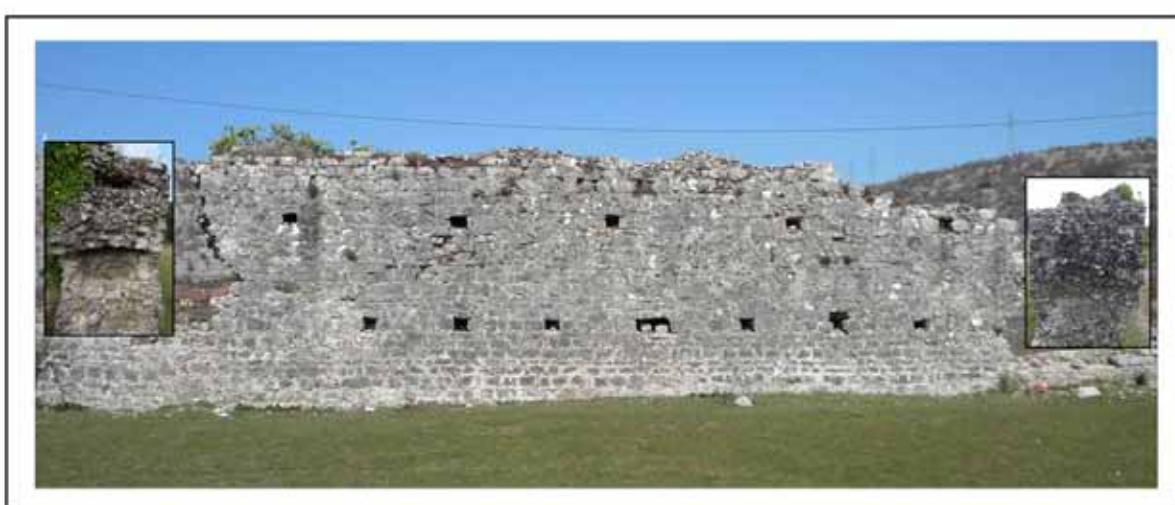
Sl. 5 - Sjeverni bedem, detalj unutrašnjeg zidnog platna i presjeka kroz bedem

Fig. 5 - The northern city wall, detail of interior face of the wall and cross-section through the city wall

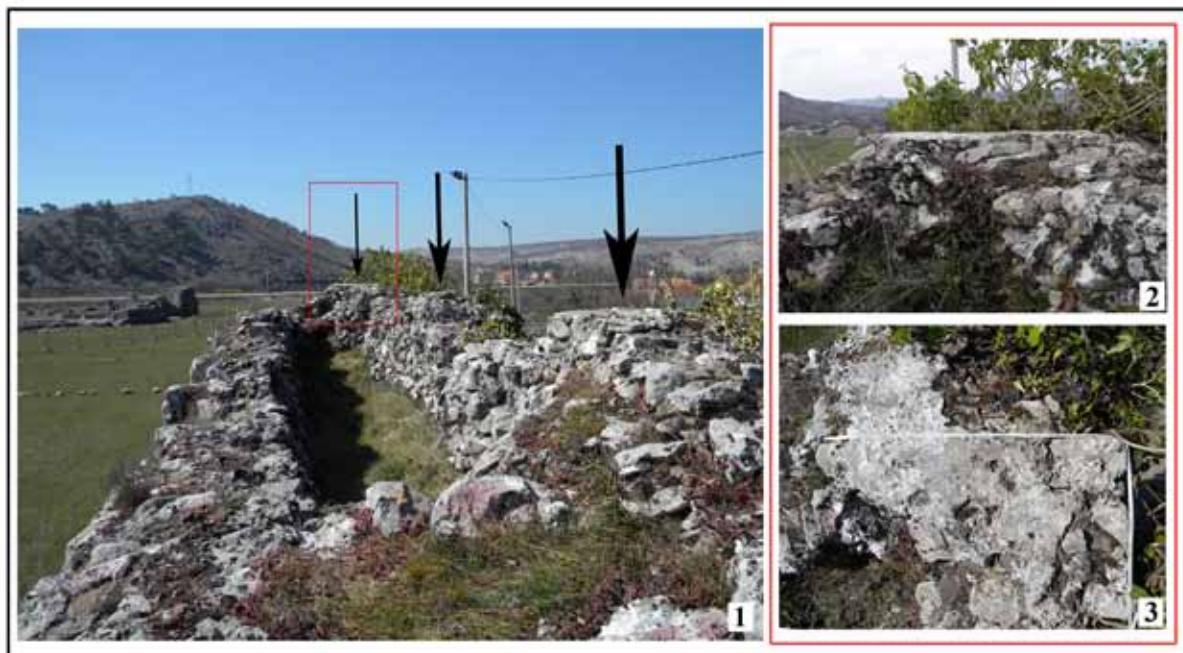
Sl. 6 - Ostaci kruništa bedema sa sačuvanim malternim površinama

Fig. 6 - The remains of the city wall crenellation with preserved mortar surfaces

sebi, je postavljen na sloju sitnog kamenja i opeke i potom lijepo zamalterisan. Najveća površina nepravilnog je oblika i dimenzija 0,60 x 0,70m (sl. 6,2-3). Omalterisane površine, sve iste nivelete, govore da na ovom dijelu bedema nije postojalo grudobrana (osim malo vjerovatno da je imao zupce a da malterne površine pripadaju djelovima između zubaca grudobrana). Visina od najviše tačke bedema do nivoa tla sa spoljnje strane bedema je 5,05m. Izračunata visina od gornjeg niza otvora do tla iznosi 3,40m s obzirom na debljinu grede i staze od oko 0,30-0,40m, dobijamo da je prostor od dna šetne staze do vrha bedema bio 1,20m.

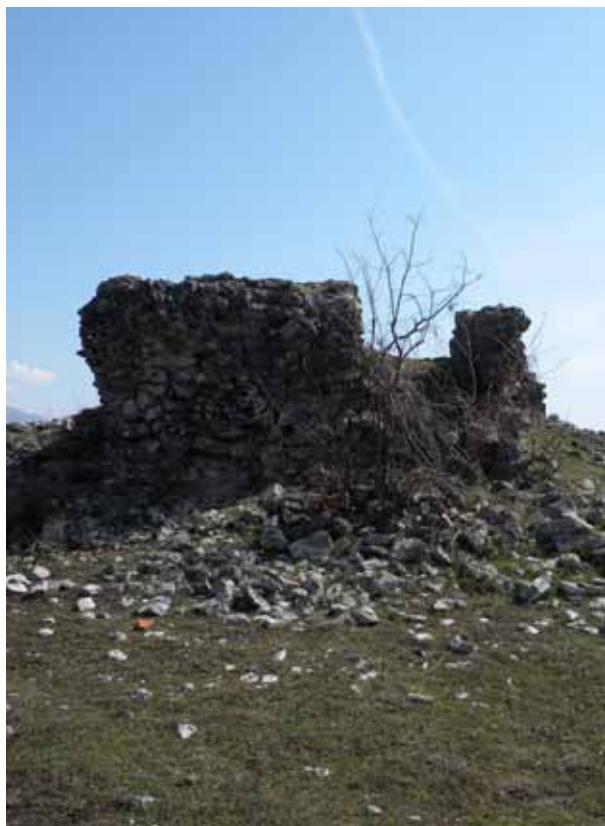
*Sl. 7 - Kula h, spoljašnji izgled sa zapada
Fig. 7 - Tower h, the outside view from the west*

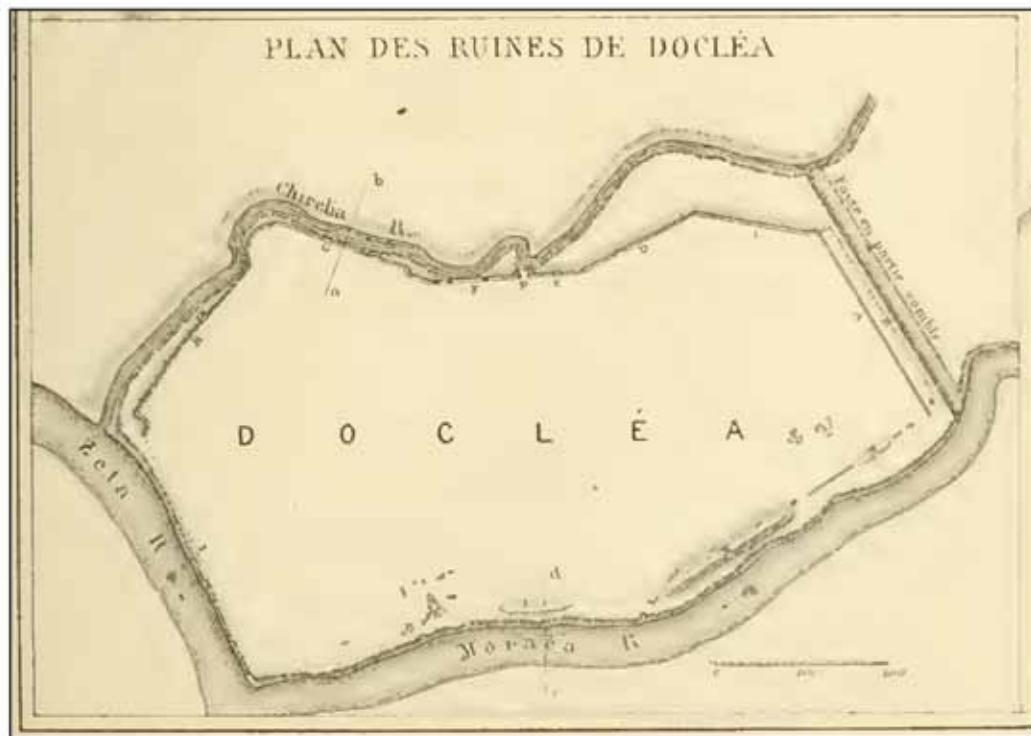
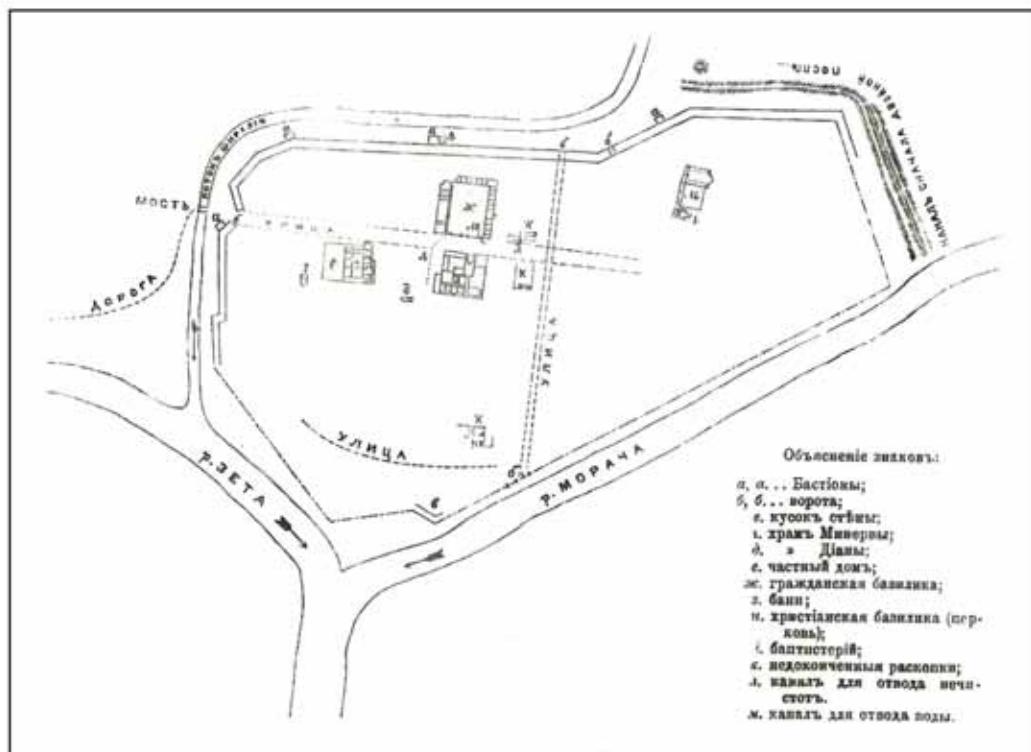
Tabla 1. Plan Dokleje: 1 - prema F. Saskiu (Saski 1882), 2 - prema P. Rovinskem (Ровинский 1909)
Plate 1. Doclea Plan:1 - by F. Saski (Saski 1882), 2 - by P. Rovinski (Ровинский 1909)

Prvi plan grada objavio je 1882. god. F. Saski i time udario temelje topografskih prikaza antičke Dokleje (T. 1.1). Na planu je ucrtao osnovne gabarite bedema, rov ispred njegovog sjeveroistočnog dijela, tragove bastiona kod ušća potoka Širalije u Zetu, nekoliko urušenih objekata unutar grada. Takođe je označio i mjesto gdje se prepostavlja antički most na Morači kao i pravac pružanja akvadukta (Saski 1882: 74-77, Pl. XIII). Nakon tri godine iskopavanja, u periodu od 1890. do 1893. god. P. Rovinski je načinio plan koji objavljuje tek 1909. god. (Ровинский 1909: 18). I pored toga što je plan poprilično šematisiran, na njemu su zabilježeni svi do tada otkriveni i poznati objekti (T. 1.2). Istraživanja engleske ekspedicije, koja su organizovana 1983. god. pronikla su urbanističku mapu grada koja se bazirala na objektima i ruševinama, i njihovom smještanju unutar gradskih zidina (T. 2.1). Stoga, gradski bedem je izведен sumarno, samo skiciran dok su neki segmenti, poput položaja mosta, dati proizvoljno (Munro *et al.* 1896: Pl. IV). Gotovo istovremeno sa prethodnim planovima, radilo se na izradi karte grada koja je postala najkompletnija karta Dokleje (T. 3.1) (Sticotti 1999). Svi prethodni planovi su zasigurno pomogli pri upotpunjavanju iste, a početke odnosno pripreme za Stikotijev plan vidimo i u dokumentima Luke Jelića gdje se nalaze skice i nacrti grada³. Skoro cijeli vijek

The first city plan was published in 1882 by F. Saski, thus laying the foundation of topographical display of ancient Doclea (Pl. 1.1). In the site plan he charted the basic dimensions of the city walls, a ditch in front of its north-eastern part, and traces of a bastion at the mouth of creek Širalija and the Zeta river. He also marked several ruined objects in the city, the assumed location of an ancient bridge over the Morača, and direction of the aqueduct (Saski 1882: 74-77, Pl. XIII). After three years of excavations from 1890 to 1893 P. Rovinski made a plan and it was published in 1909 (Ровинский 1909: 18). Although the plan is quite schematized, it includes all previously discovered and known objects (Pl. 1.2). British research expedition which was organized in 1983 gave a plan of the city, which was based on the buildings and ruins, and their positions inside the city walls (Pl. 2.1). Therefore, the city walls were outlined, only sketched with some segments, such as the position of the bridge, given arbitrarily (Munro *et al.* 1896: Pl. IV). Almost simultaneously with the previous plans, a map of the city was being created, and it has become the most complete map of Doclea (Pl. 3.1) (Sticotti 1999). All previous plans had definitely helped in completing the map, and the beginnings, or preparations, for Sticotti's plan can be seen in the documents of Luka Jelić, where sketches and outlines of the city can be found³. For almost a

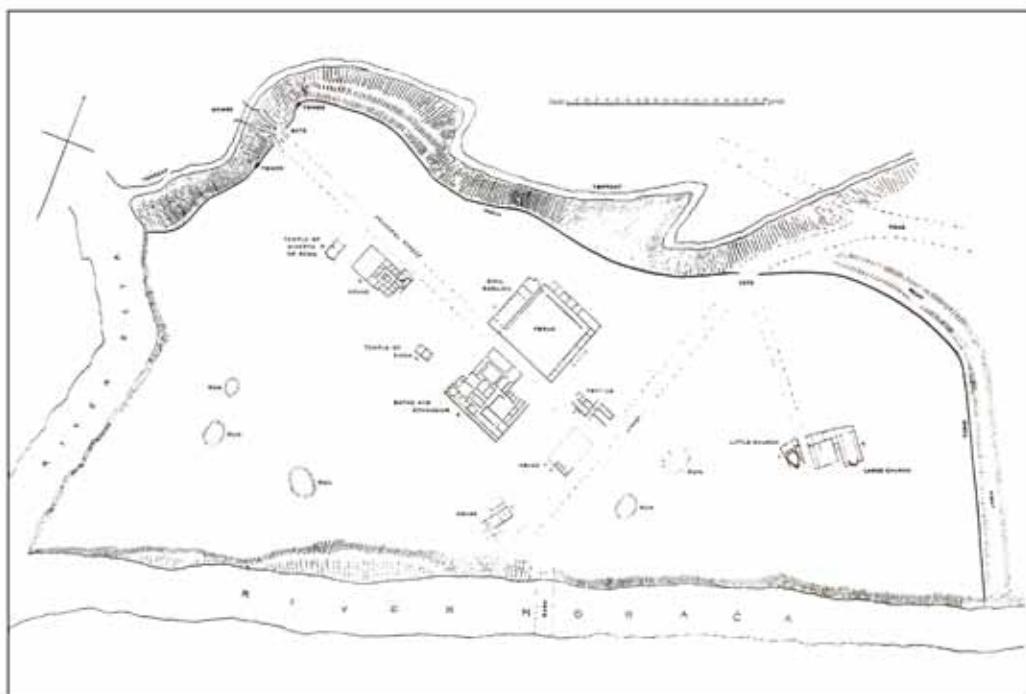
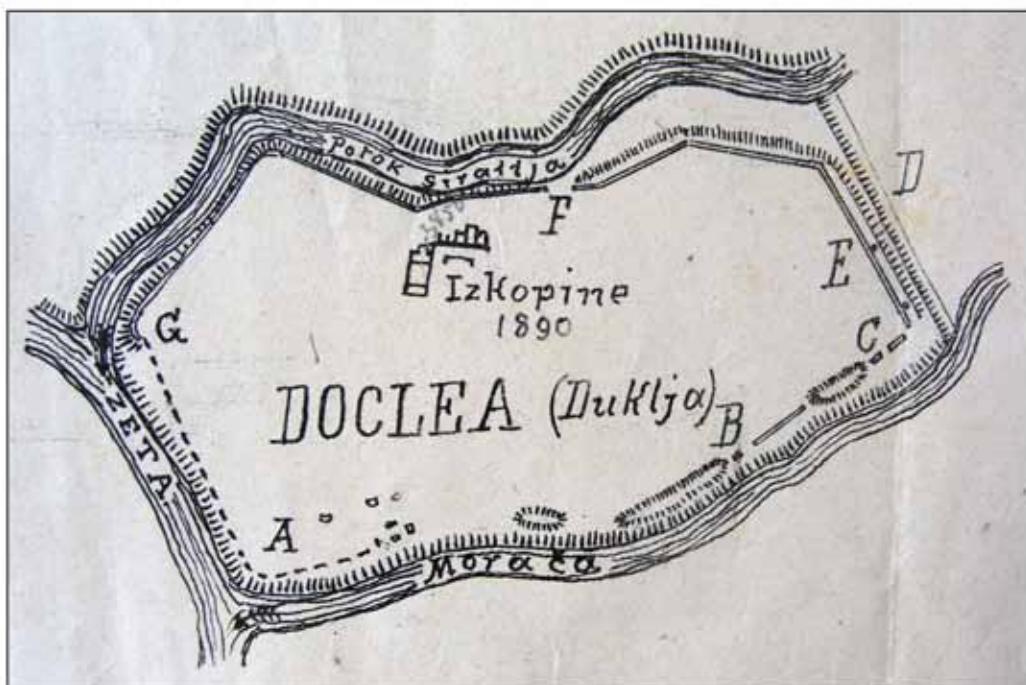
Tabla 2. Plan Dokleje: 1 - prema J.A.R. Munrou (Munro et al. 1896), 2 - na skici L. Jelića 1892. god.
Plate 2. Doclea Plan: 1 - by J.A.R. Munro (Munro et al. 1896), 2 - outline of L. Jelić, 1892

³ Plan prikazan na T. 2.2 pronaden je među dokumentima arhiva Luke Jelića u Arheološkom muzeju u Splitu. Osim njega pronađena je i skica na kojoj su ucrtane kule na sjevernom bedemu i skicirani pravci prostiranja istog. Podatke i plan nam je ljubazno ustupila Tatjana Koprivica, viši naučni istraživač Istoriskog instituta Crne Gore, te joj na tome svesrdno zahvaljujemo.

³ The plan given in Pl. 2.2 was found among the documents in the archive of Luka Jelić in The Archaeological Museum in Split. Except for that plan, a sketch which shows towers on the northern city walls and a layout of the fortification. The plan and all the data were kindly lent by Tatjana Koprivica, a

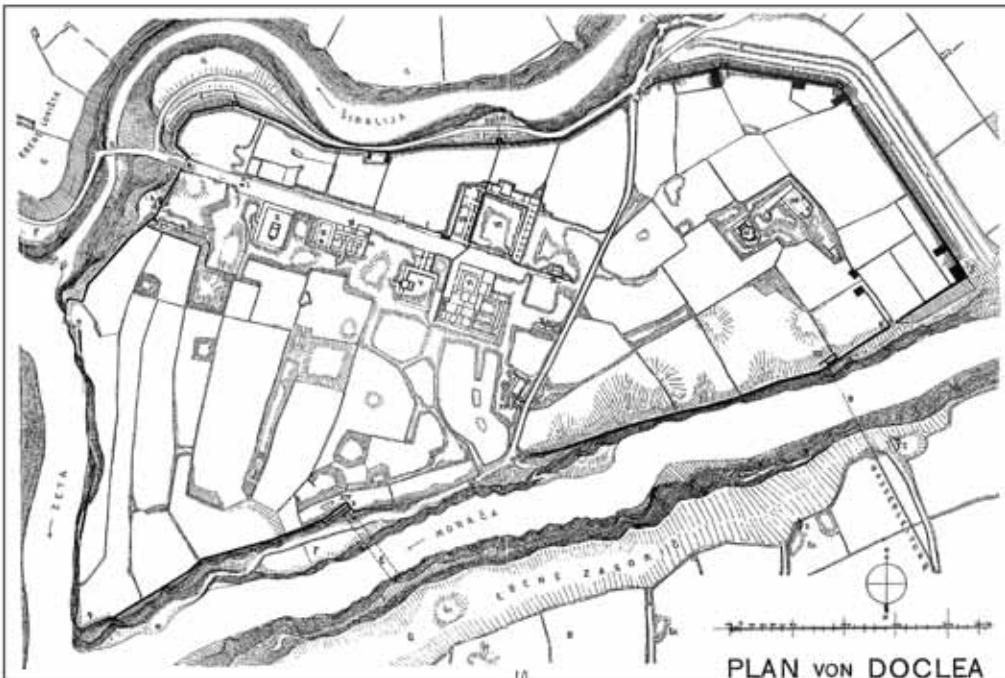
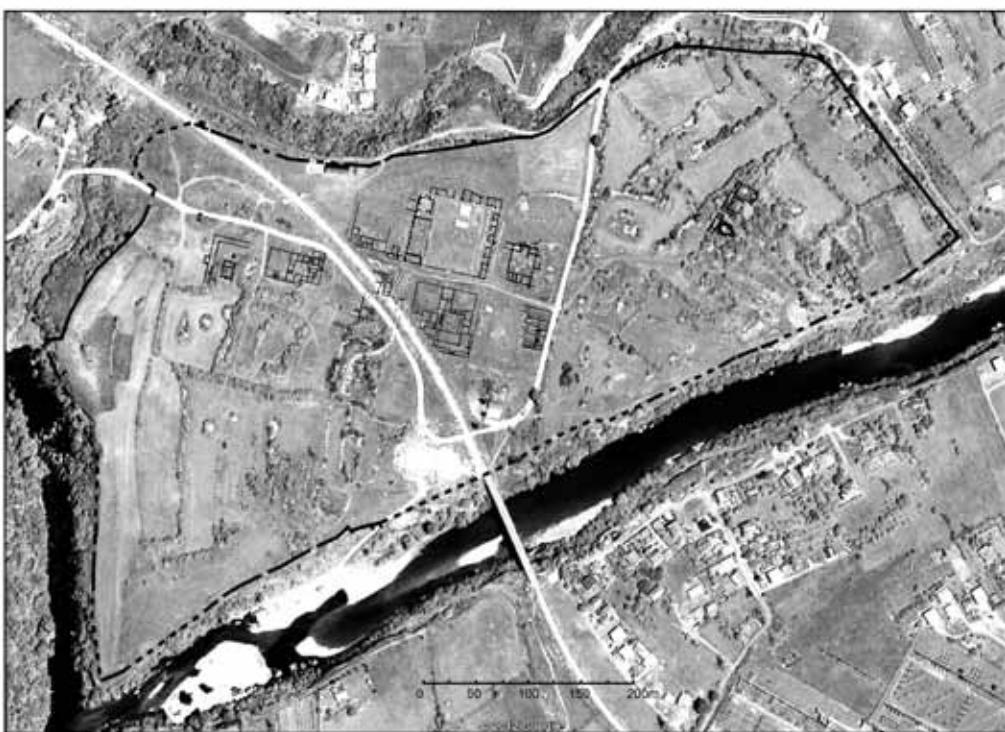
Tabla 3. Plan Dokleje: 1 - prema P. Stikotiju (Sticotti 1999), 2 - nastao preklapanjem plana dobijenog nakon snimanja 2012 i satelitskog snimka

Plate 3. Doclea Plan: 1 - by P. Sticotti (Sticotti 1999), 2 - formed by overlapping the plan obtained after 2012 surveying and a satellite image

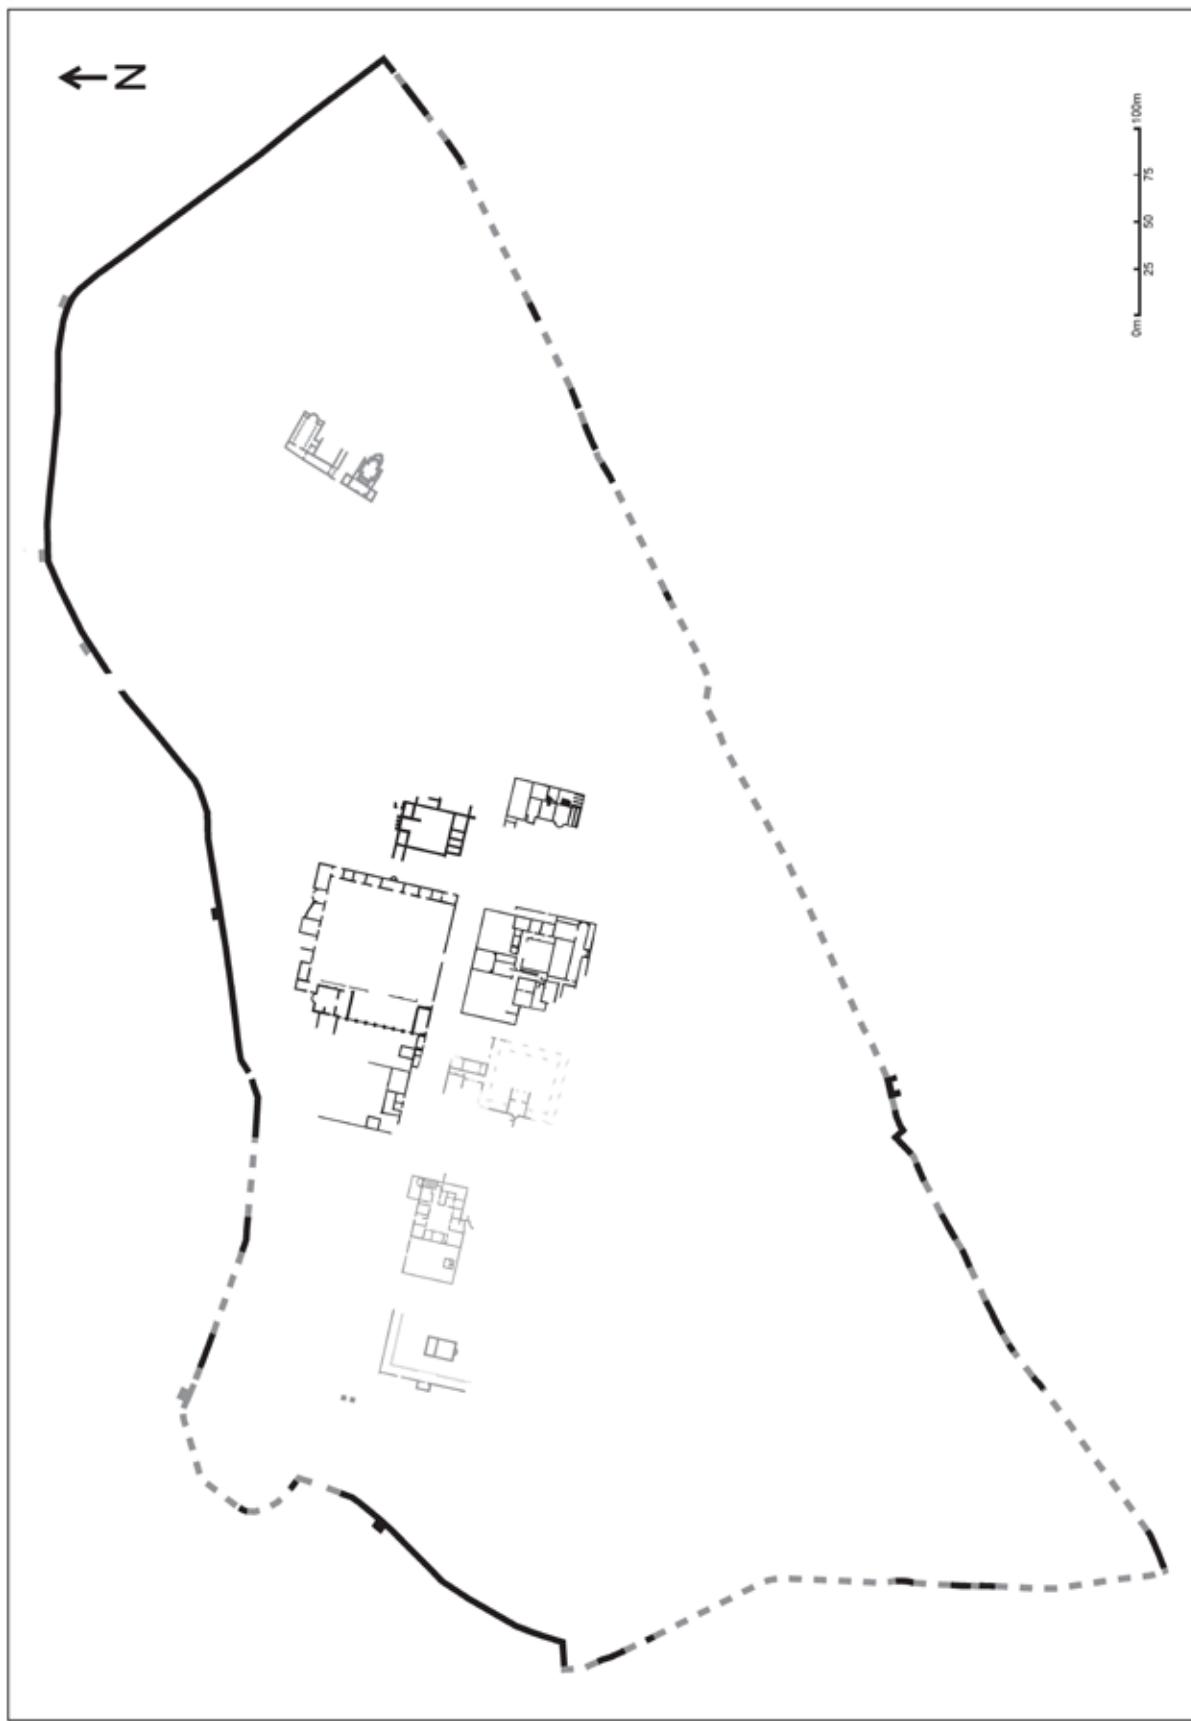
Tabla 4. Plan Dokleje nakon snimanja 2012. god.

Plate 4. Doclea Plan: after 2012 surveying

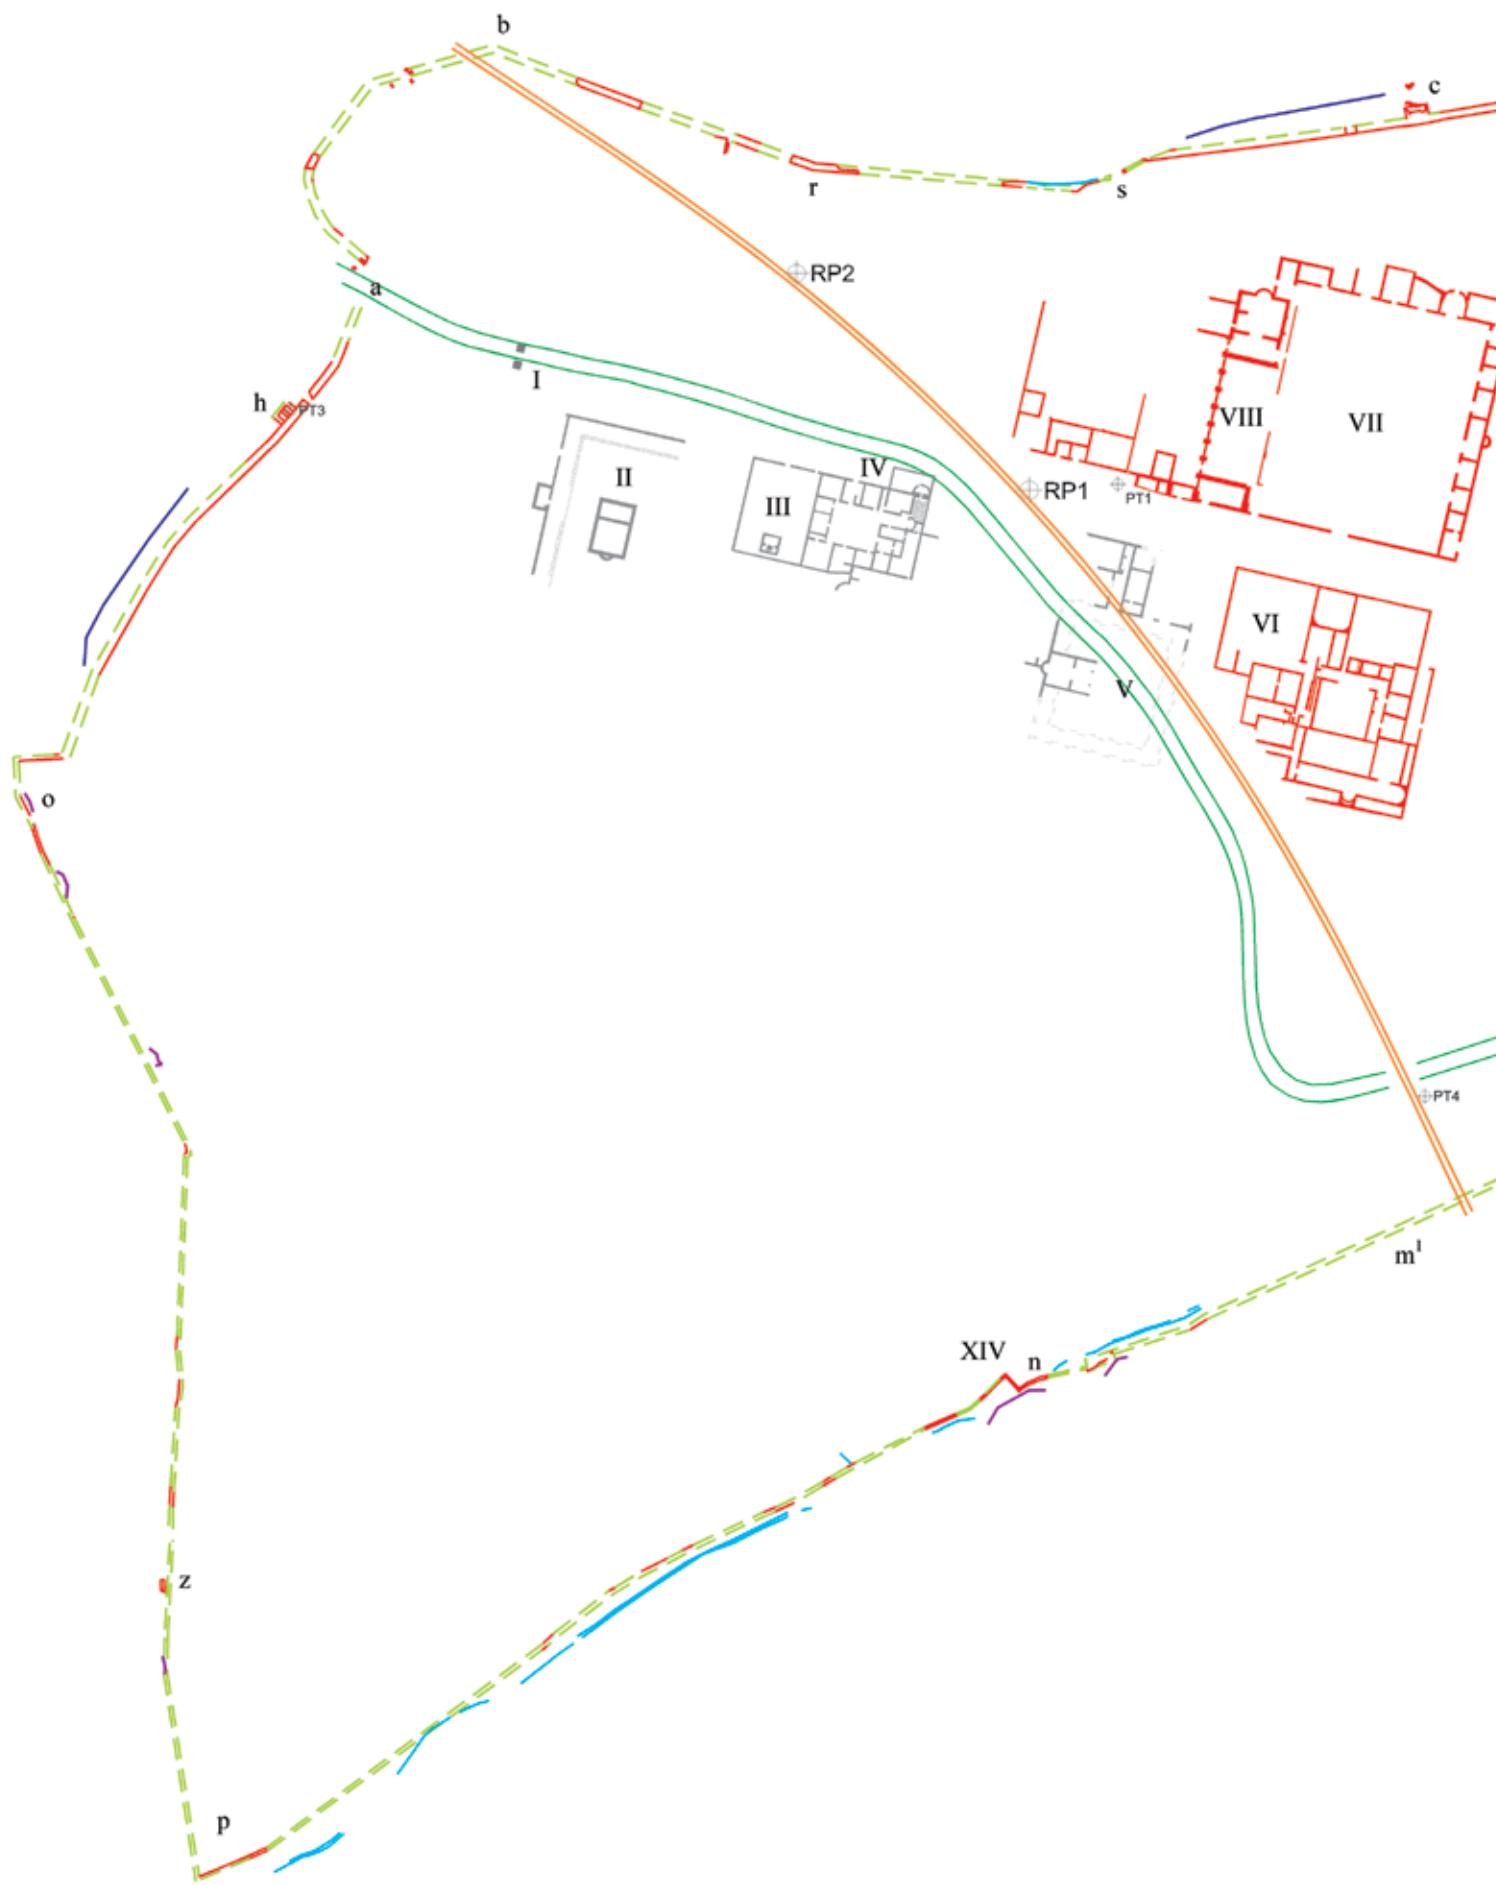
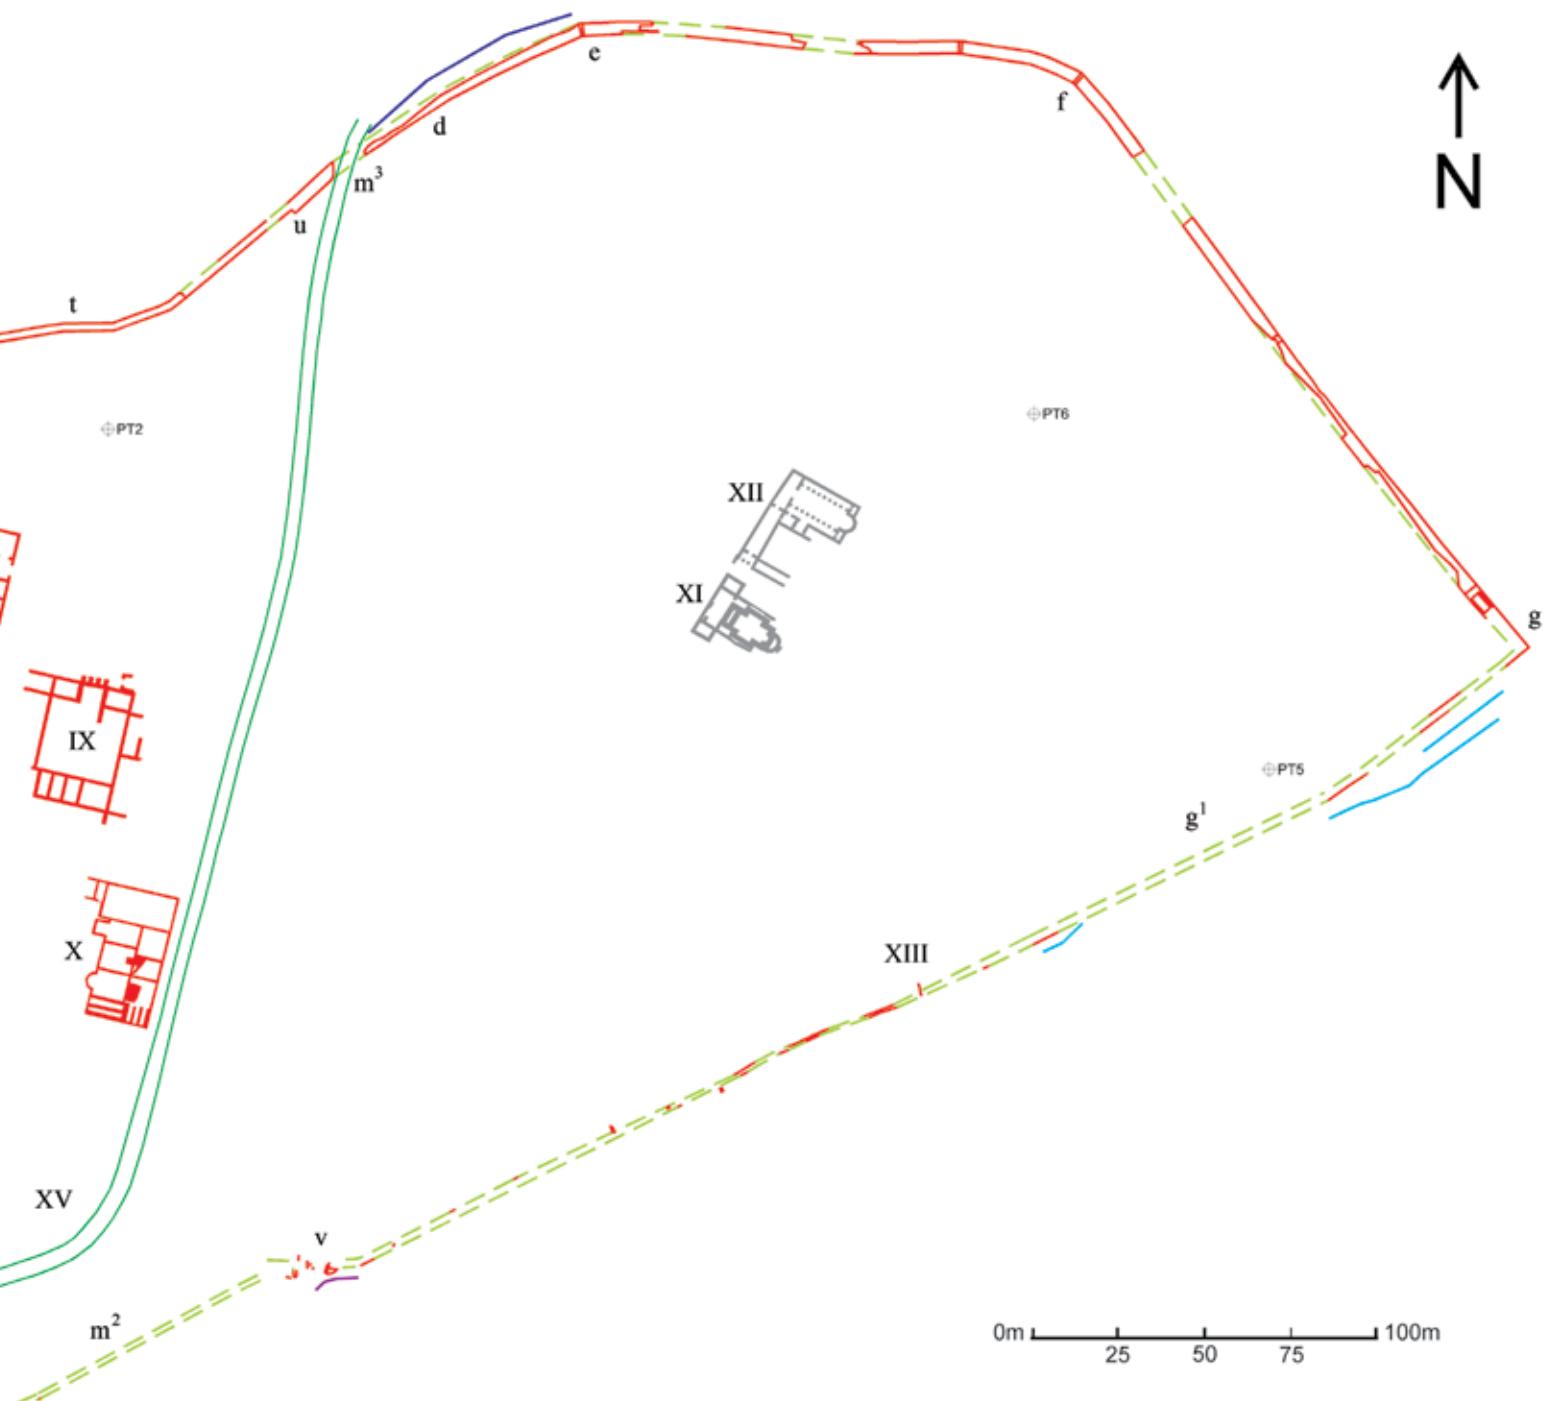
Tabla 5. Situacioni plan Dokleje sa snimljenim i prikupljenim podacima 2012. god.

Plate 5. Situation plan of Doclea with surveyed and collected data, 2012

Prostor uokviren gradskim zidovima obuhvata površinu od 25,4 hektara. Zidovi su podignuti su uz sam rub obala rijeka te gradu daju nepravilan podužni oblik. Sjeverozapadni sjeverni i sjeveroistočni dio platoa Dokleje utvrđen je moćnim vertikalanim bedemom širine 2,20/3,70m, na kojem su postavljane pravougaone kule. Trasa bedema koja prati tok rijeke Morače, i naročito tok Zete, najslabije je očuvana i ona je sazidana manje masivnim zidom. Jednoobraznost gradnje koju su primjetili prvi istraživači ukazuje da su najvjeroatnije rađeni u jednoj epohi. Na osnovu prostiranja glavnih rimskih ulica i razmaka na zidovima moguće je prepostaviti ulazne kapije kod mjesta *a, m3, g1, m1-m2*. Pri opisu bedema i njegovog prostiranja, koji će uslijediti u narednim redovima, koristiti gradski plan prikazan na tabli T. 5.

found in the following lines, please use the urban city plan shown in Pl. 5.
